## **RPM Noise Record**

**Abstract:** Persistent noise features on the ISAC rotary position monitor (RPM) transverse beam intensity profiles are recorded and investigated. Results of a device inspection after venting HEBT diagnostic box-0 are recorded.

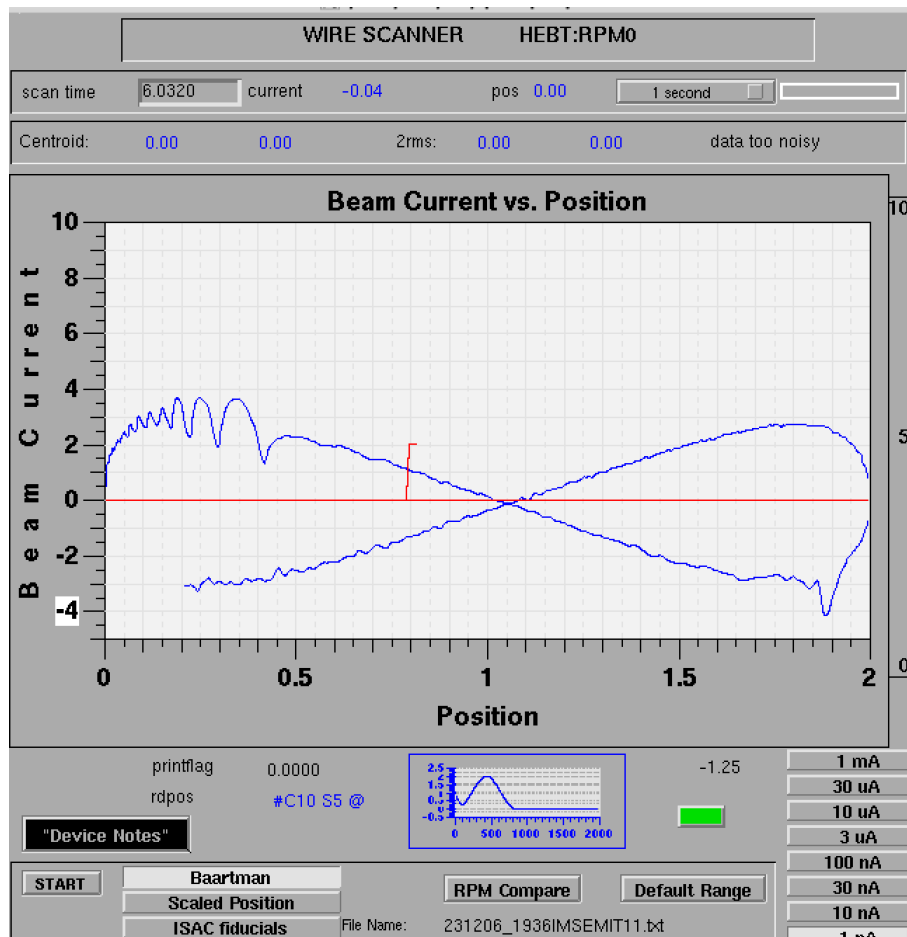
- HEBT-DB0 was vented on 2024-01-05 and opened for access.
- The RPM noise profile shown in Figure 1 was captured at atmosphere.
- The amplitude of the noise feature decreased by a factor of  $\sim 40$  after venting. The overall shape remained essentially unchanged.
- The in/out positioning of HEBT:FC0 did not affect HEBT:RPM0 readback.
- On Figure 1, the top-left, higher-frequency noise was found to correlate with the position of the RPM's BNC 90° connector, shown in Figure 2.
- A field of roughly 4-5 G was found near the solenoid valve, at the rough location of the BNC right-angle.

Figure 1: HEBT:RPM0 noise profile, scanned at atmosphere with HEBT diagnostic box-0 open.

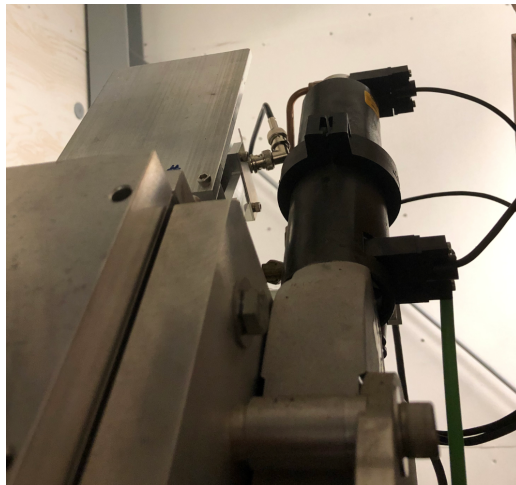
Figure 2: HEBT:RPM0's readback signal is connected to a BNC cable, including a right angle adapter, to avoid cable collision with HEBT isolation valve-0 (HEBT:IV0)'s solenoid valve, which is the black cylindrical object on the top right hand side of the image.

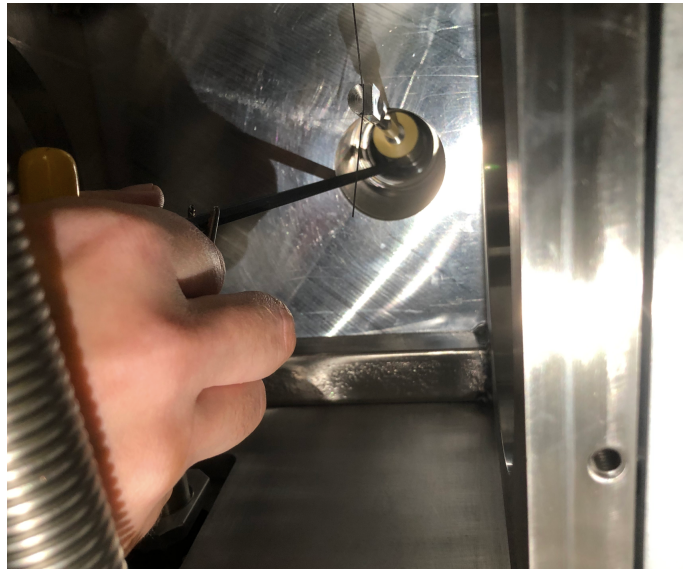
- A grounded screwdriver was used to gently scrape the surface of the RPM's insulated base (Fig. 3). **This was found to significantly alter the RPM's readback noise profile.**

- Figure 3 shows the resting position of the RPM, which is tilted to avoid beam trajectory interference. This rendered only one half of the RPM accessible for contact with grounded metal. Only the accessible face was contacted for this report.

Figure 3: A grounded screwdriver is used to gently scrape the surface of the RPM's insulated base. This was found to alter the RPM's readback noise profile.

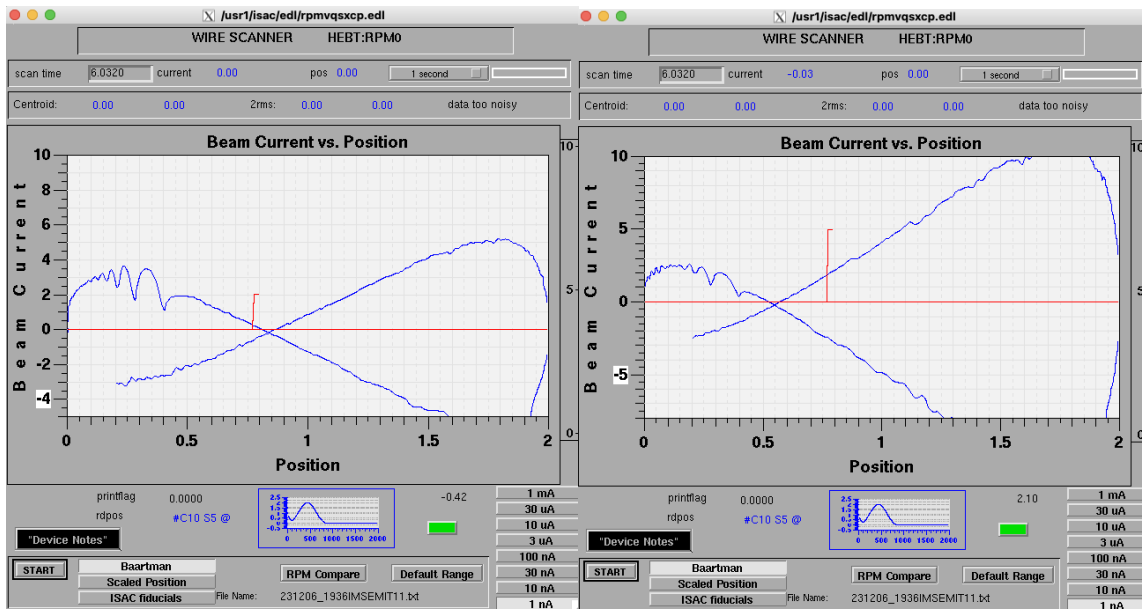
- Figure 4 shows the effect of two separate contacts between grounded screwdriver and RPM. Observe the asymmetrization of the noise profile, which increases in amplitude on the right hand side. The zero-crossing also shifts toward the left.

Figure 4: **Left:** HEBT:RPM0 noise profile after a roughly 1 second contact between screwdriver and RPM. **Right:** RPM profile after another ~1 second contact.

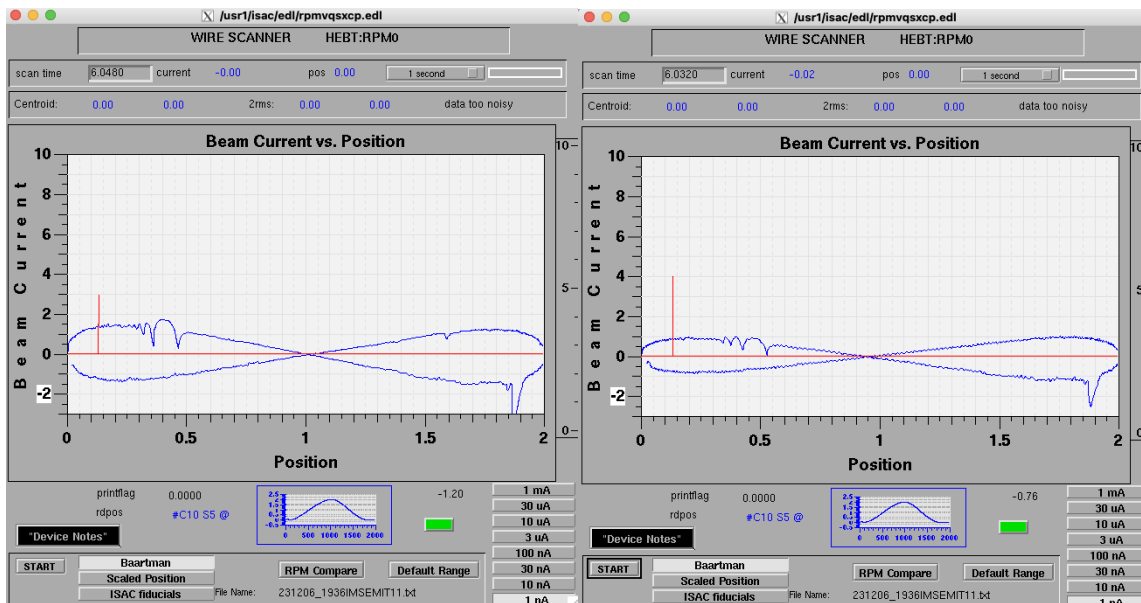
- On 2024-01-11, HEBT-DB0 was vented and opened again.
- Compressed CO<sub>2</sub> from a cannister was sprayed onto the exposed RPM's base, this was found to reduce the noise feature by a factor of roughly two, shown in Figure 5.

Figure 5: **Left:** An initial application of compressed CO<sub>2</sub> was carried out on the RPM's base, reducing the noise from that shown in Figure 1. **Right:** After several applications of CO<sub>2</sub>, a minimum amplitude in the noise profile was reached, beyond which more compressed gas had no effect.

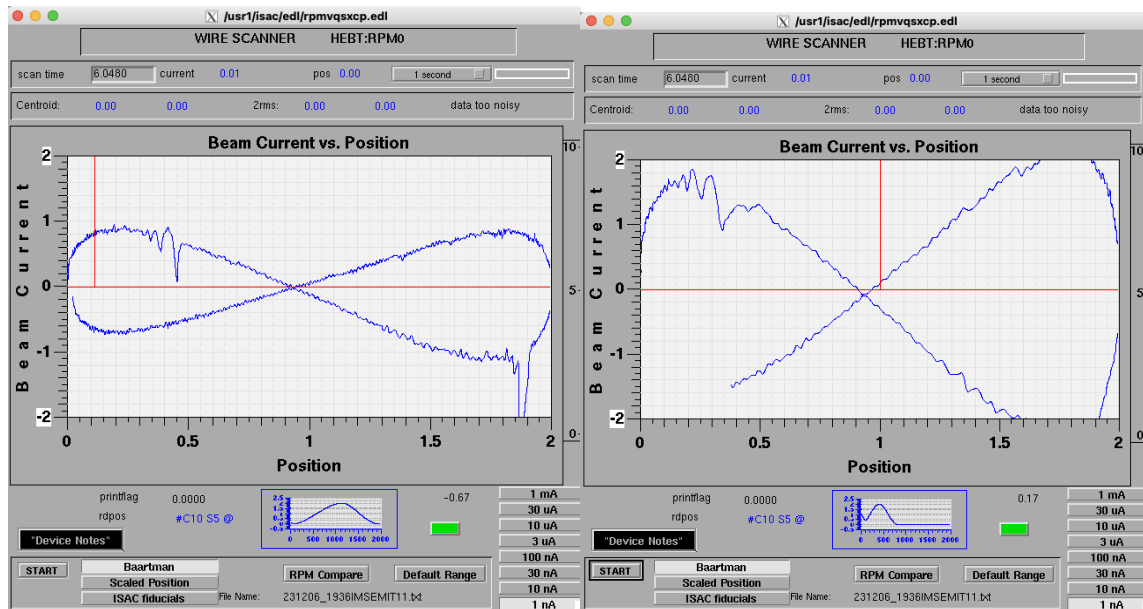
- A potentiometer was installed on the RPM, allowing for variation of its sweep speed.
- It was found that the persistent noise pattern's amplitude correlated strongly with the sweep speed. Slower sweeps produced less noise; faster sweeps caused larger noise.

Figure 6: **Left:** RPM0's sweep was run at relatively normal speed, producing the shown noise patten. **Right:** The RPM's speed was increased, producing a larger noise amplitude. In both images, the position vs time array is shown at the bottom of the plots. For the left plot, the relatively slow sweep fills the position plot, while for the right plot the scan is completed after about one third of the position array.
